# Unlocking the secret of snail tracks

**The solar industry is investigating so-called snail tracks – small, dark lines that appear on modules**

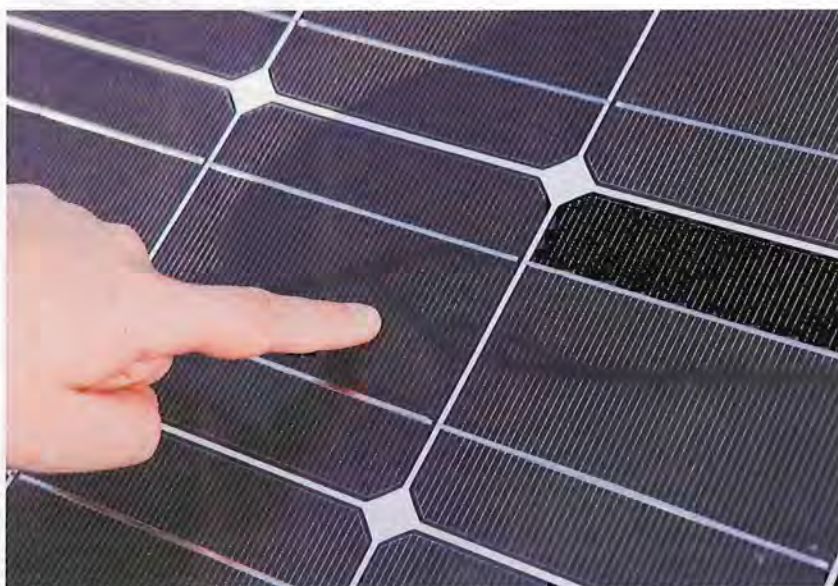
Snail tracks: These finger-thick dark lines crisscrossing solar cells result from a chemical reaction. The cause and effects of the reaction are still being researched.

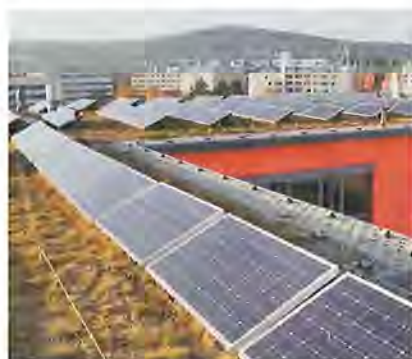
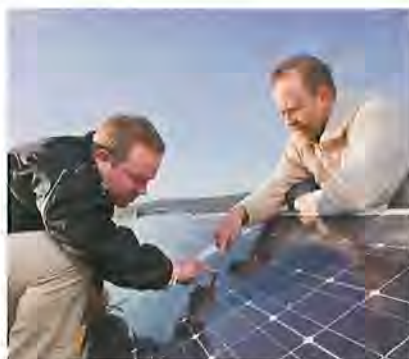
The system at the vocational college in Hesse, Germany, was connected to the grid in December 2010. In the fall of 2011, the operator discovered snail tracks on 10 percent of the modules, which were manufactured by CEEG in China. A close inspection revealed that the contact fingers in the affected areas seem to have turned brown.

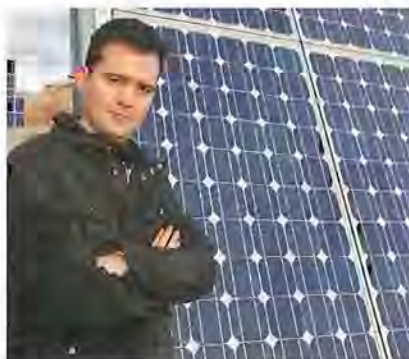
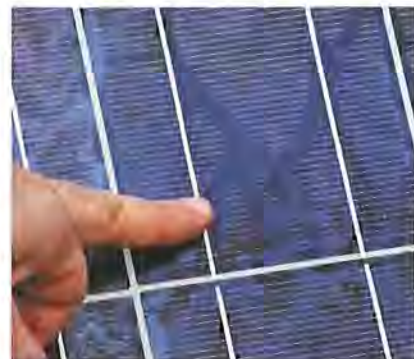
Most of the operators who reported snail tracks to PHOTON did not observe any impact on the output of their modules. But Javier Hernández from Ingeniería Medioambiental Helios in Spain says that his system's yield has fallen by around 20 percent. CSI, the manufacturer, has not taken any remedial action to date.

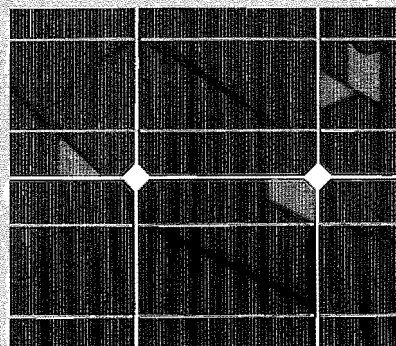
Snail tracks that result in isolated cell segments are indicated with red lines in this diagram. Such an area occurs when the connections of contact fingers to both bus bars are broken.

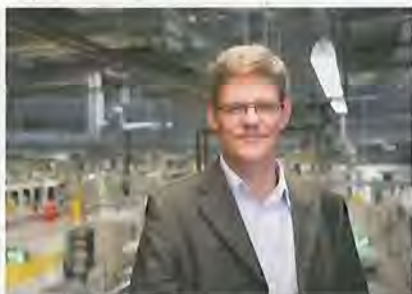
In contrast to other manufacturers, Q-Cells considers snail tracks to be a defect. »Our standard is to have our modules free of electrical and optical defects,« says Peter Wawer, Q-Cells' head of technology.
