# Unlocking the secret of snail tracks

**The solar industry is investigating so-called snail tracks – small, dark lines that appear on modules**

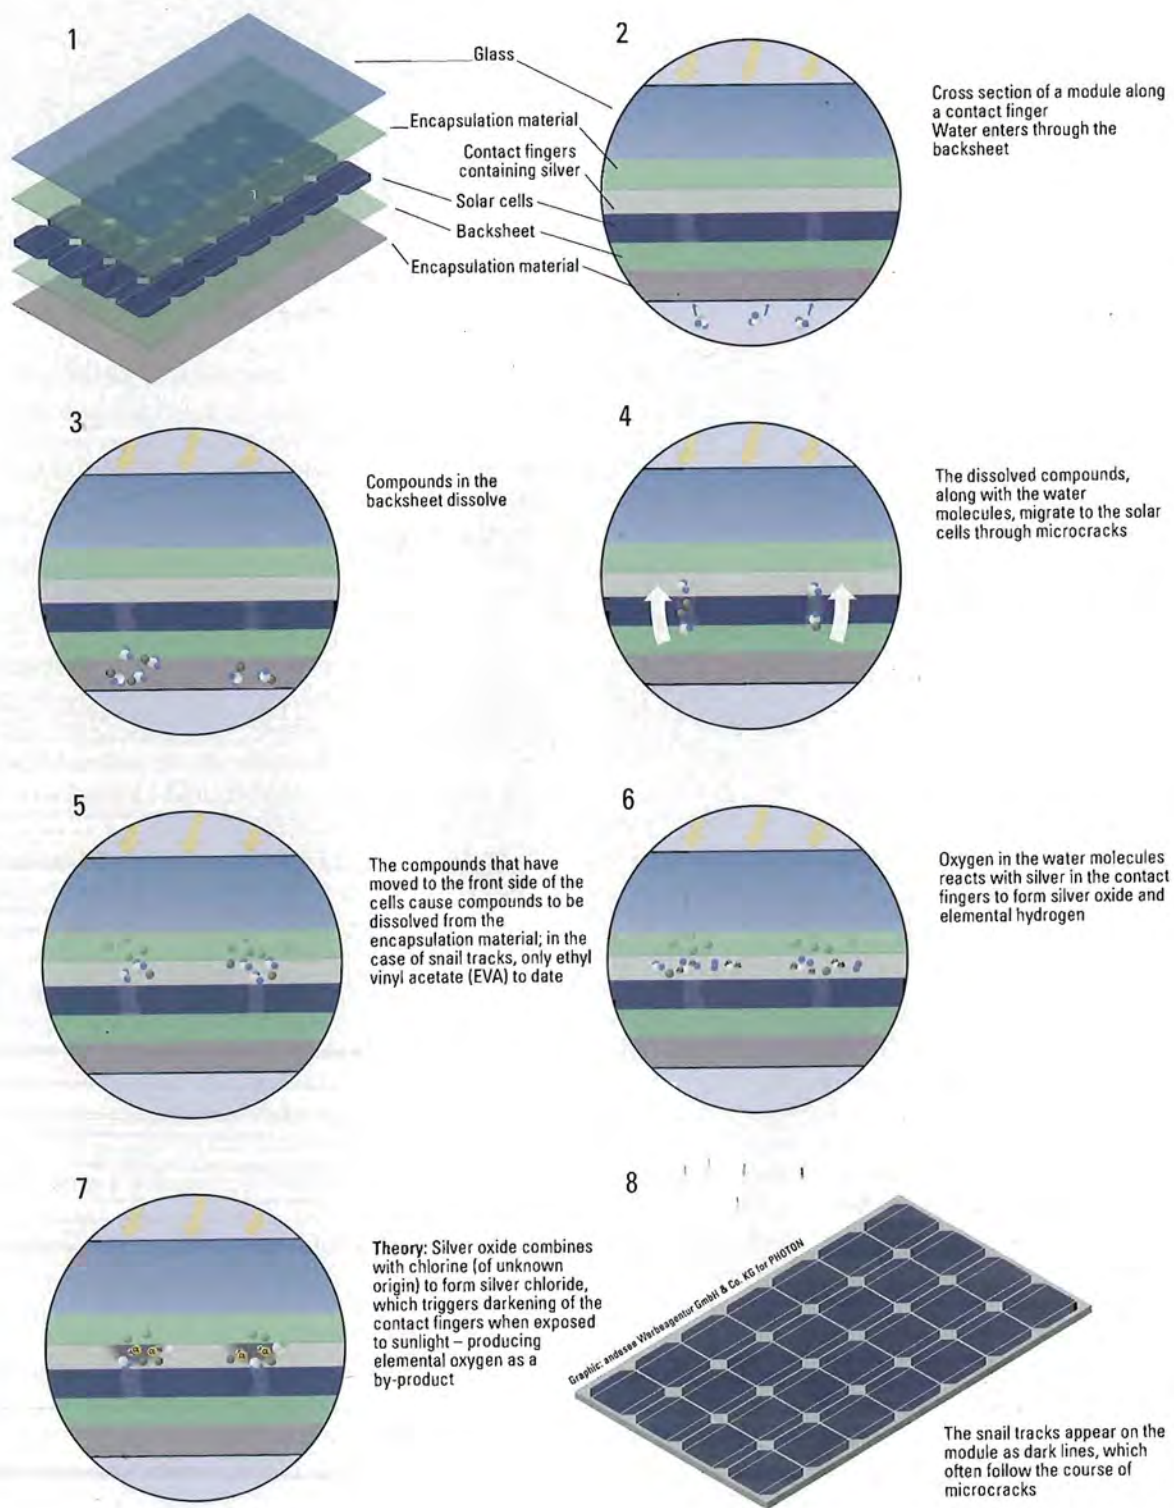
## Formation of snail tracks according to current research

it. His team initially examined the silver contact fingers on several modules. What is perceived as a darkening of the contact grid is, according to this research, a thin layer of polymer deposited over the fingers. The contacts themselves do not seem to be subject to corrosion, and power losses on the modules were generally not observed. The polymer closely resembles the encapsulant material ethylene vinyl acetate (EVA) used in about 90 percent of all modules, with one difference: it contains many phosphorous oxides (phosphorous dioxides and trioxides). Where these compounds come from and how they trigger a separation of part of the EVA film remains unclear.

One of the companies contacted by PHOTON, Schüco International KG, supports the hypothesis that increased electrical resistance on a microcrack generates heat in the vicinity, causing substances in the EVA film to solubilize. These substances are then deposited on the cell as a dark residue. Schüco is still conducting its analysis, and any findings must be considered preliminary.
